INTERIM REPORT:
PHASE I OF ROCKY MOUNTAIN ARSENAL
SEWER INVESTIGATIONS

Prepared by
Morrison-Knudsen Engineers, Inc.
Denver, Colorado 80290

April, 1986

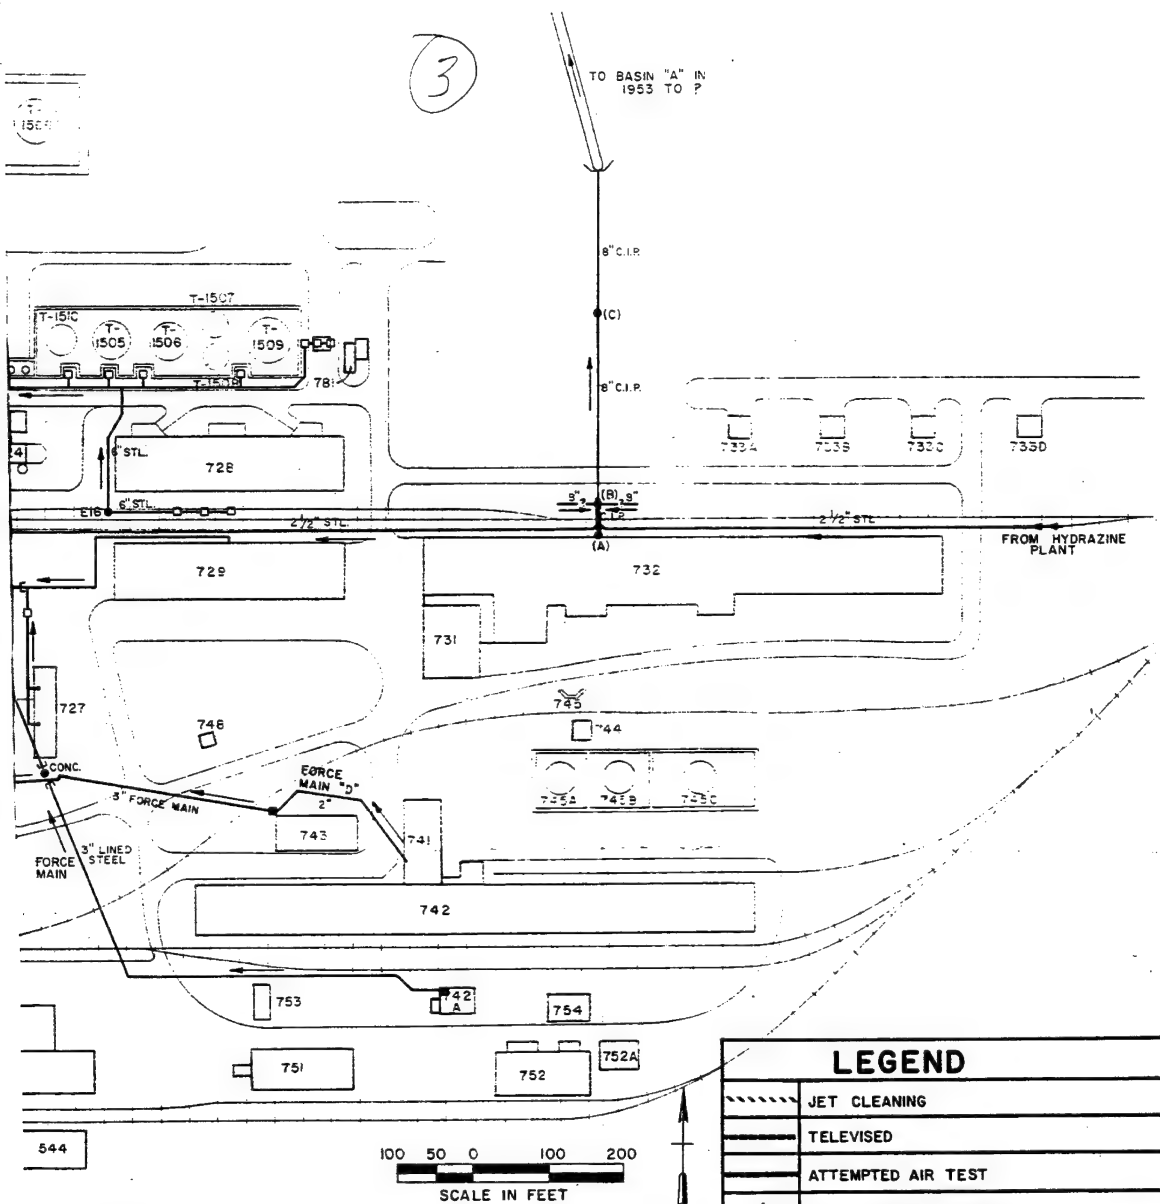
LEGEND			
////	JET CLEANING		
---	TELEVIEWED		
---	ATTEMPTED AIR TEST		
△	WATER SAMPLE LOCATION		
○	CANDIDATE EXCAVATION SITE		
ROCKY MOUNTAIN ARSENAL SEWER INVESTIGATIONS			
FIGURE 3.8 SAMPLING AND FIELD INVESTIGATION SITES, EAST SIDE OF SOUTH PLANTS CONTAMINATED SEWER			
Drawn By: SMR	Date: 4-17-86	Scale: 1"=100'	Exhibit No.
App'd. By: ALN	Date: 4-17-86	Drawn By: ALN	
Design By:	Date:	Eng. No.:	
App'd. By:	Date:	Eng. No.:	
MORRISON-KNUDSEN ENGINEERS, INC. A CORPORATION OF COLORADO 1700 Broadway, Suite 1600 Denver, Colorado 80290
